US Army Corps
of Engineers

Construction Engineering
Research Laboratory

USACERL TECHNICAL REPORT M-90/06

Evaluation of Abrasion-Resistant Metallized Coatings for Civil Works Applications

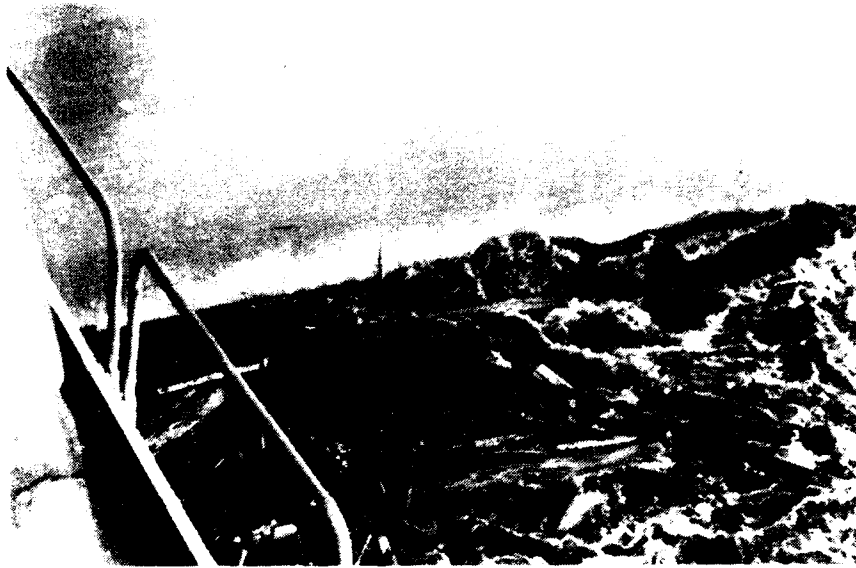
Figure 2. Large debris against downstream skinplates.

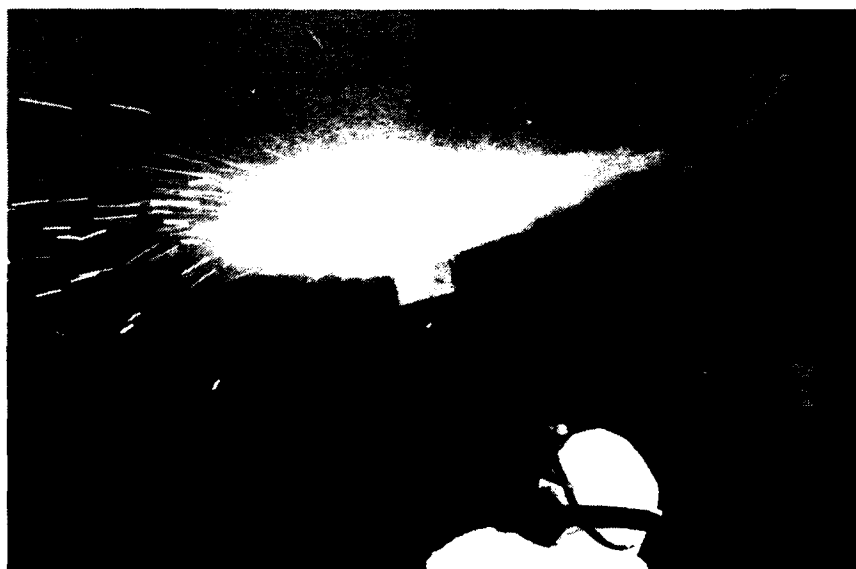
Figure 5. Two-wire arc coating application.

Figure 5 shows the application of aluminum-bronze by two-wire arc at Belleville. The two-wire arc method produced a bright green light, necessitating the use of dark filters such as a welder would use. The process also produced a high level of noise. Observers and workers wore ear protection at all times while the two-wire arc gun was in use. The arc process also produced a significant quantity of smoke and metal fumes. The smoke caused considerable staining of areas adjacent to the metallizing gun, including the aluminum-bronze itself.

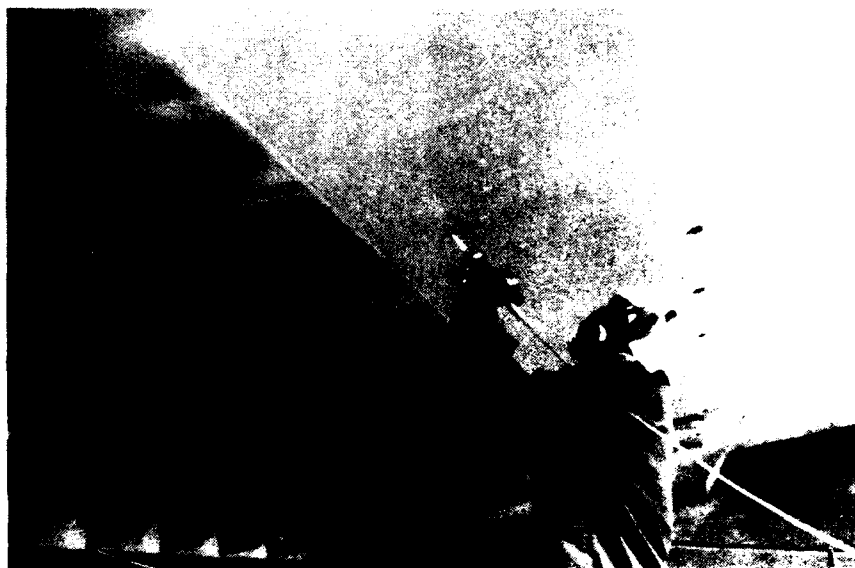
Figure 6. Wire flame spray gun coating application.

Wire flame spray with 85-15 zinc-aluminum is much less noisy than the two-wire arc process. The light produced by the process can be observed directly without discomfort. Much less smoking and metal fumes are created by this process than by electric arc spray. No occurrences of metal frame fever were noted during application of 85-15.

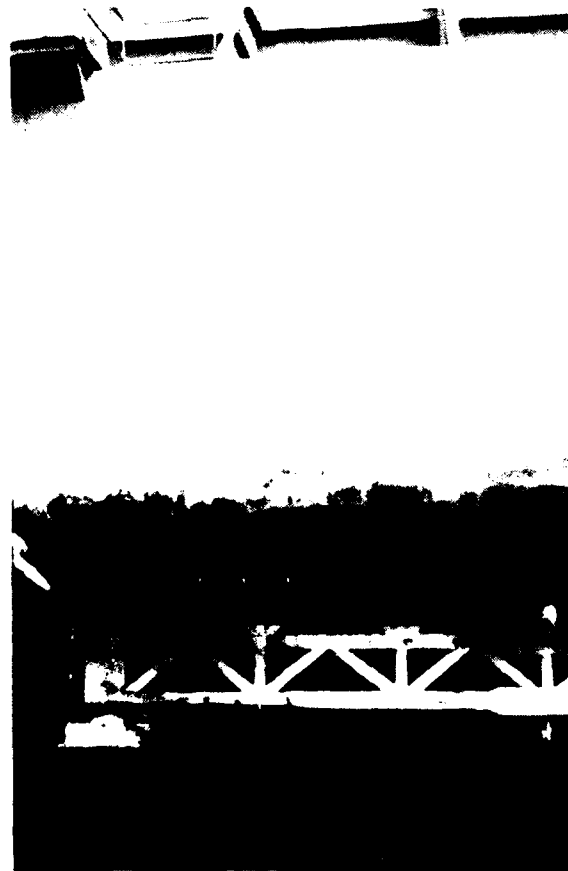
Figure 8. Aluminum-bronze coated tainter gate section after 20 months.

Figure 9. Aluminum-bronze coated tainter gate section after 20 months--close up.

Figures 8 and 9 depict approximately the same area as Figure 7 after 20 months of service. A general worsening of the overall condition is evident. Figure 10 shows the growth of the delaminated area, described above, after 20 months. After 20 months the bays and upstream skinplate continued to be in better overall condition than the radius and upper metallized portions.

Large areas of sealer were worn off in some areas, particularly along the nose section. The wash primer with vinyl topcoats exhibits areas of white and gray, evidence that the gray topcoat has eroded to expose the white intermediate coat. Portions of the metallized surface exhibit greater pinpoint rusting than do adjacent metallized areas. Thickness measurements indicated that these areas often correspond to areas of relatively thin metallizing.

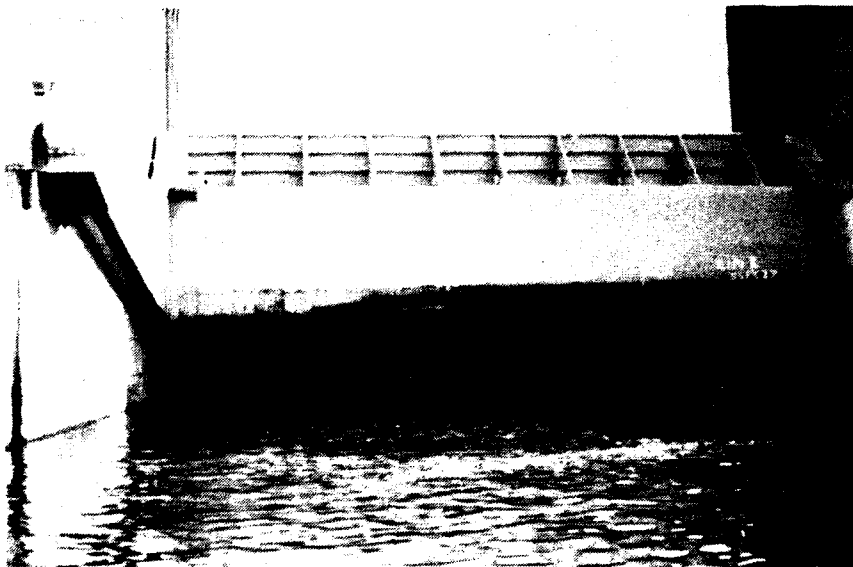
Figure 15. Tainter gate No. 5 at Belleville locks and dam.

Figure 15 is a full-length view of tainter gate No. 5 at Belleville Locks and Dam, taken in June 1988. Both the zinc and zinc-aluminum coatings had been in test for 10 months, and the aluminum-bronze and stainless steel had been in test for 20 months. The zinc-aluminum coating supported more algal growth than the other metallized coatings; the entire nose section was bright green from the growth. Lower portions of the zinc-aluminum coating are brown, which may be dead algae.

No red rust was visible on the zinc-aluminum coated section, and there was no measurable loss of coating thickness. The coating surface was somewhat polished along the curved nose-section, indicating that some wear was occurring.

The zinc metallized coating was also in excellent condition. The pure zinc coating does not appear to support as much algal growth as the zinc-aluminum coating. The lower portions of the gate were brown, probably from river scum adhering to the rough metallized surface. No red rust or cuts in the zinc coating were visible. There was no measurable loss of coating thickness, although there was some polishing of the zinc along the nose section.
